# Another Record Set at Super Bowl Stadium

In a job that normally should have required 18 weeks to complete, a flooring manufacturer, surface preparation contractor, and flooring installation contractor managed to prepare and install a waterproof flooring system to approximately 350,000 sq ft (31,500 sq m) of concrete in Houston's Reliant Stadium over 18 days in December 2003, just two months before the stadium was to host Super Bowl XXXVIII.

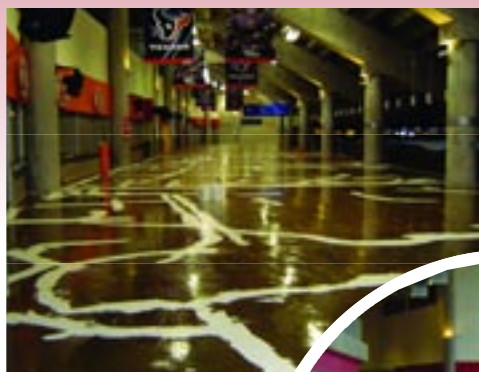
Floor repair in progress. Cracks and joints were repaired with an elastomeric coating.

Next, crews applied a 20-mil (500-micrometer) coat of an elastomeric membrane (211) by squeegee and back-rolling. Sand was broadcast over the membrane to the saturation point. Once the membrane cured, the excess sand was swept up, and the floor was again blown down. Crews then applied a 16-mil (400-micrometer) coat of an epoxy (201) and broadcast more sand. Following sweeping and blow down, the contractor applied another coat of the epoxy to a DFT of 10 mils (250 micrometers) using the same squeegee and backrolling procedure. A topcoat of a water-borne urethane (236) was rolled to a DFT of 3 mils (75 micrometers).
